Dam Design Old vs. New

Homogeneous Earth Retention Dam

Old Construction Methods

New Construction Methods

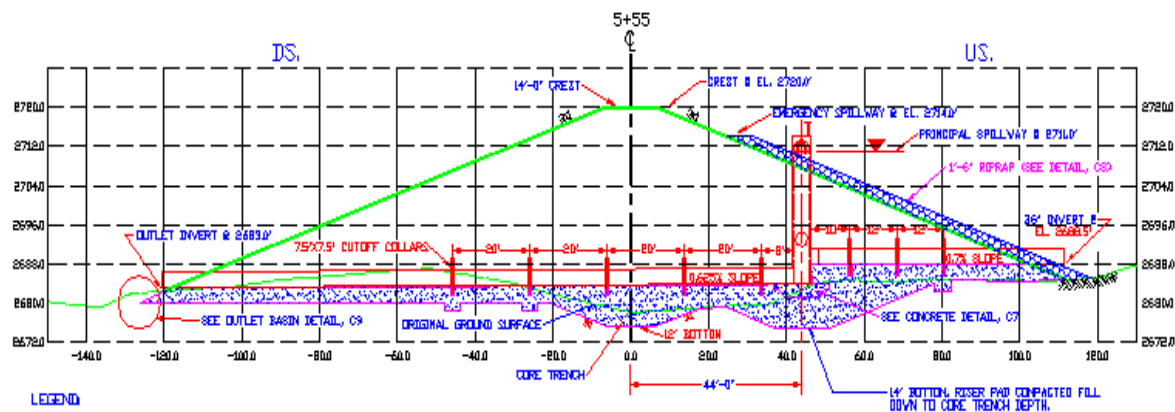
CROSS SECTION AT PIPE STATION 5+55

- AREA TO BE OVERDIGGATED AND COMPACTED BELOW STRUCTURE WITH MINIMUM WIDTH 12 FT. AND MAXIMUM SLOPE 3:1. AREA AROUND CUTOFF COLLARS REQUIRED 8 FT. FROM EDGES OF COLLAR.

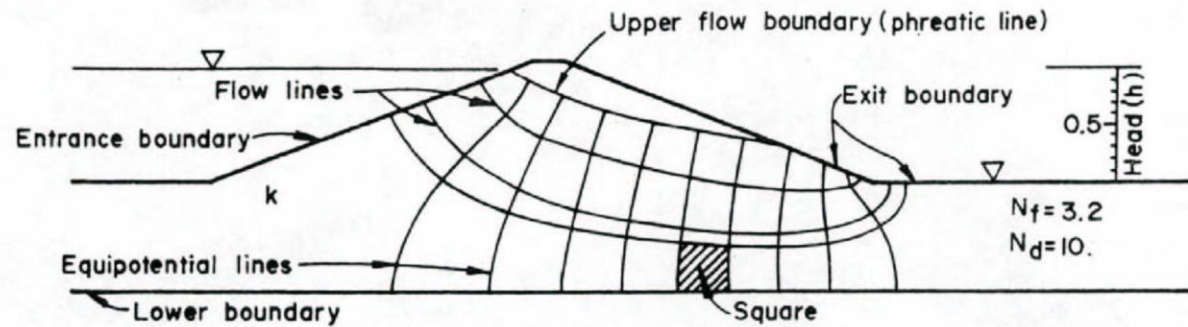
(a) Nomenclature

1. Flow and equipotential lines intersect at right angles and are chosen to form curvilinear squares.
2. Flow quantity between all pairs of adjacent flow lines (in all flow channels) is the same.
3. Energy loss between all pairs of equipotential lines is the same.
4. Velocity and hydraulic gradient are a function of the spacing between flow and equipotential lines.
5. Lines within the net are smooth curves.
6. Squares at a discharge face exposed to the atmosphere may be incomplete.
7. Equipotential lines intersect the phreatic line at equal increments of elevation.

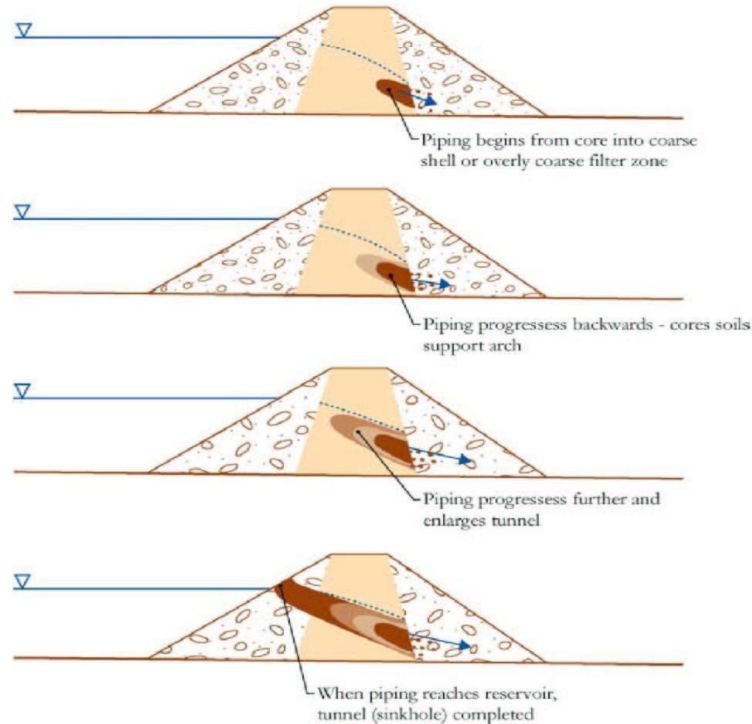
Piping scenario VI - Piping of core zone into coarse downstream shell or overly coarse filter zone

No Filter Between Core & Coarse Shell

- Migration of fines into shell zone
- Progressive tunnel erosion
- Eventual piping failure

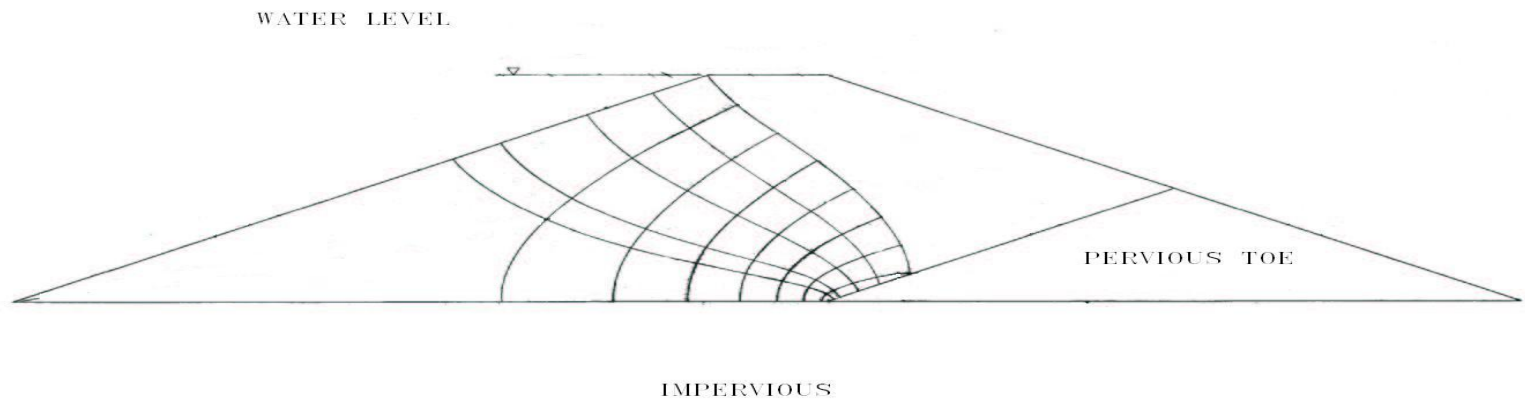
EMBANKMENT WITH PERVIOUS TOE DRAIN

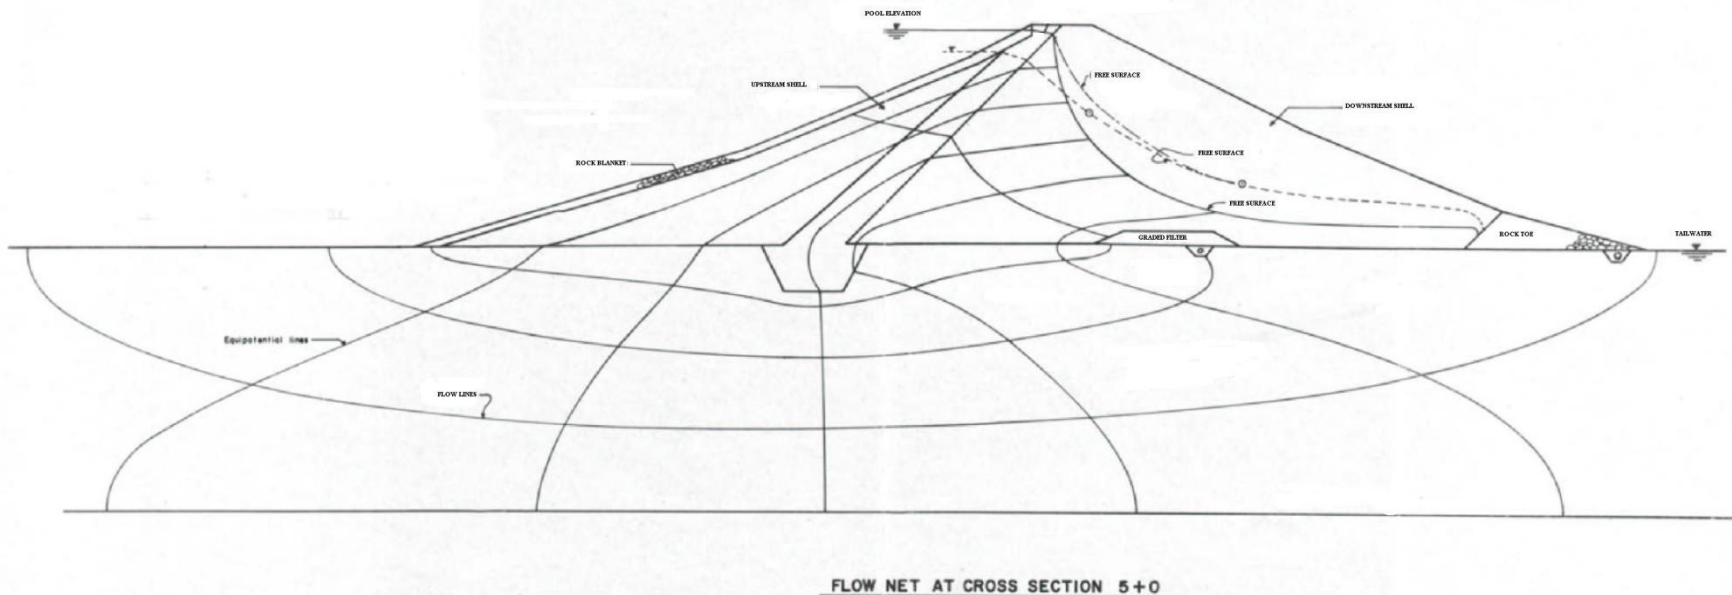
MULTI ZONED EMBANKMENT WITH TOE DRAIN

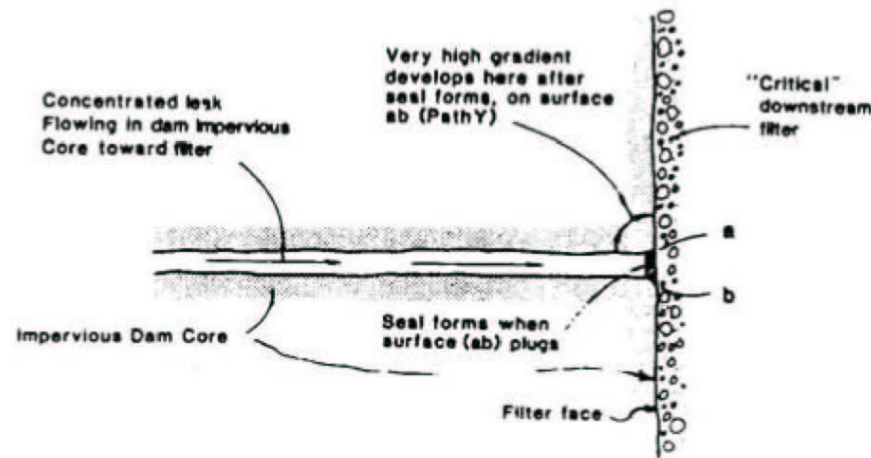
- In the Slot test, water under high pressure passes through the simulated crack & the filter
- Eroded particles of the base soil collect at the filter face and stop flow in the crack

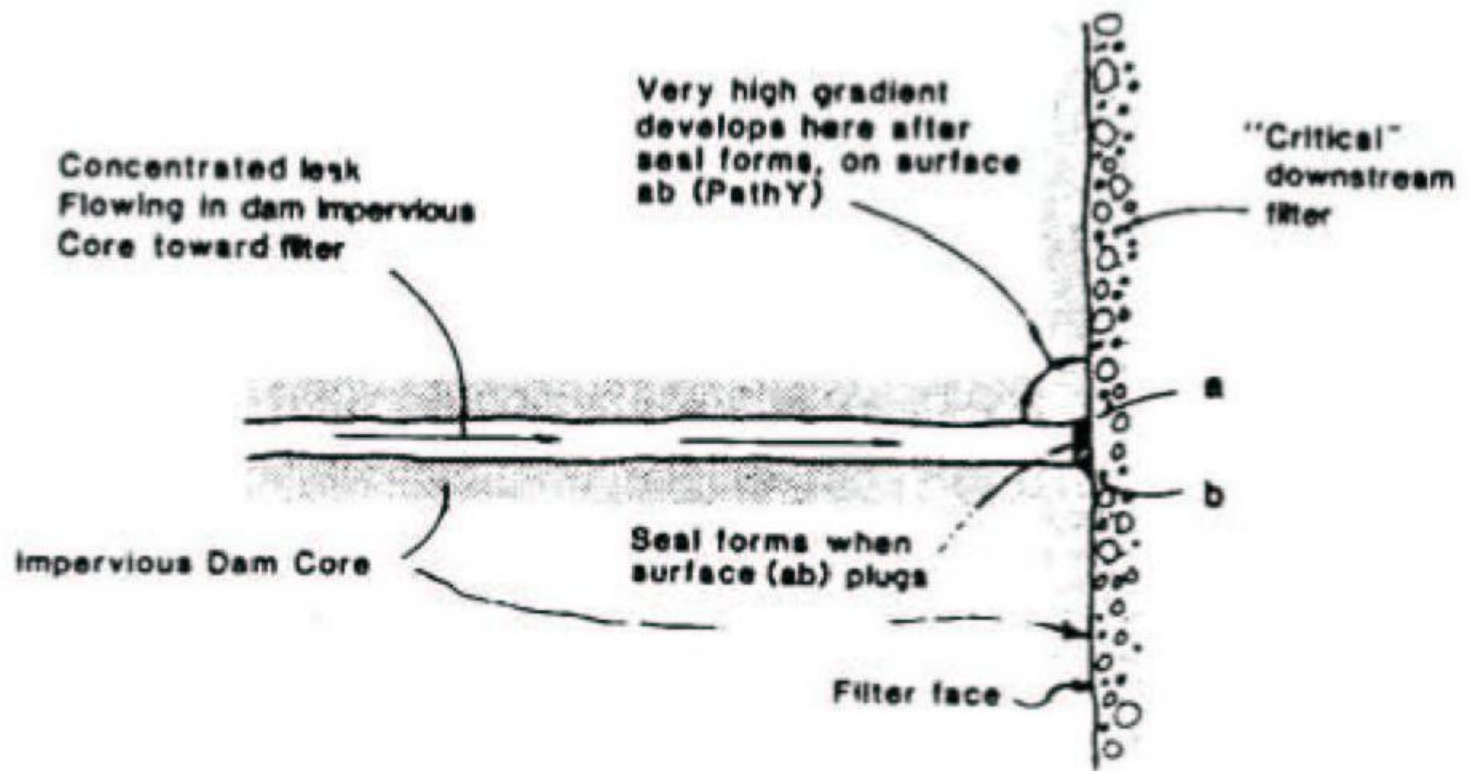
FIG. 1.—Sketch Showing Concentrated Leak Through Dam Core Discharging Into Downstream Filter (No Scale)
